## Ground Investigation Report

Proposed Residential Development

Cefn Isaf, Merthyr Tydfil

Site: Cefn Isaf, Merthyr Tydfil  
Document Title: Ground Investigation Report  
Document no.: STV6119-R01 Rev A  
Date: November 2023  
Client: Merthyr Valley Homes Limited  
Issuing office: Soiltechnics Ltd  
Cedar Barn, White Lodge, Walgrave, Northampton. NN6 9PY  
Tel: 01604 781 877 E-mail: [mail@soiltechnics.net](mailto:mail@soiltechnics.net)

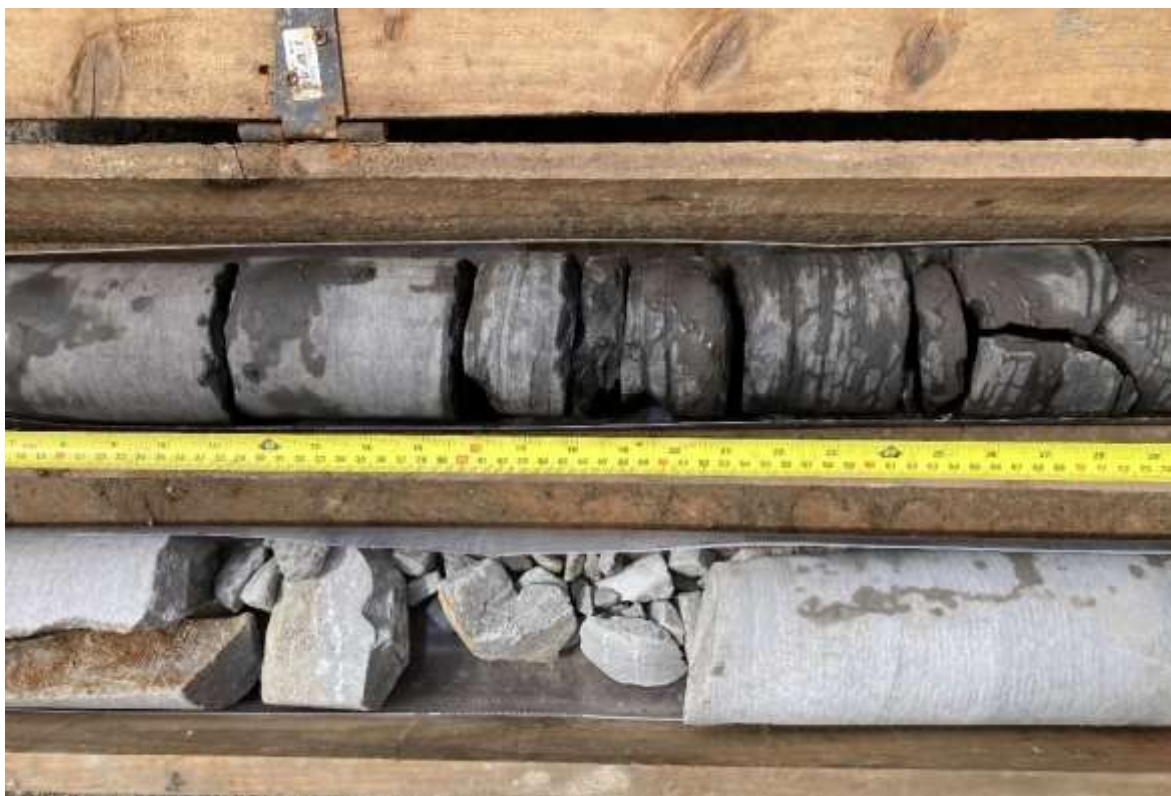
Figure 6-F: Bishopstone Mudstone Formation encountered between 10.5m and 13.5 within BH01

- 6.5.1 Bishopstone Mudstone Formation was located beneath the Devensian Till. The base of the unit was not penetrated.
- 6.5.2 Bishopstone Mudstone Formation was typically encountered as weak, grey, thinly to thickly bedded, argillaceous sandstone with closely spaced to medium spaced bedding fractures, occasionally infilled with soft, grey, slightly sandy, slightly gravelly clay. Occasional beds of medium strong, light grey limestone were also encountered.
- 6.5.3 A photograph of the typical Bishopston Mudstone Formation encountered is presented below.

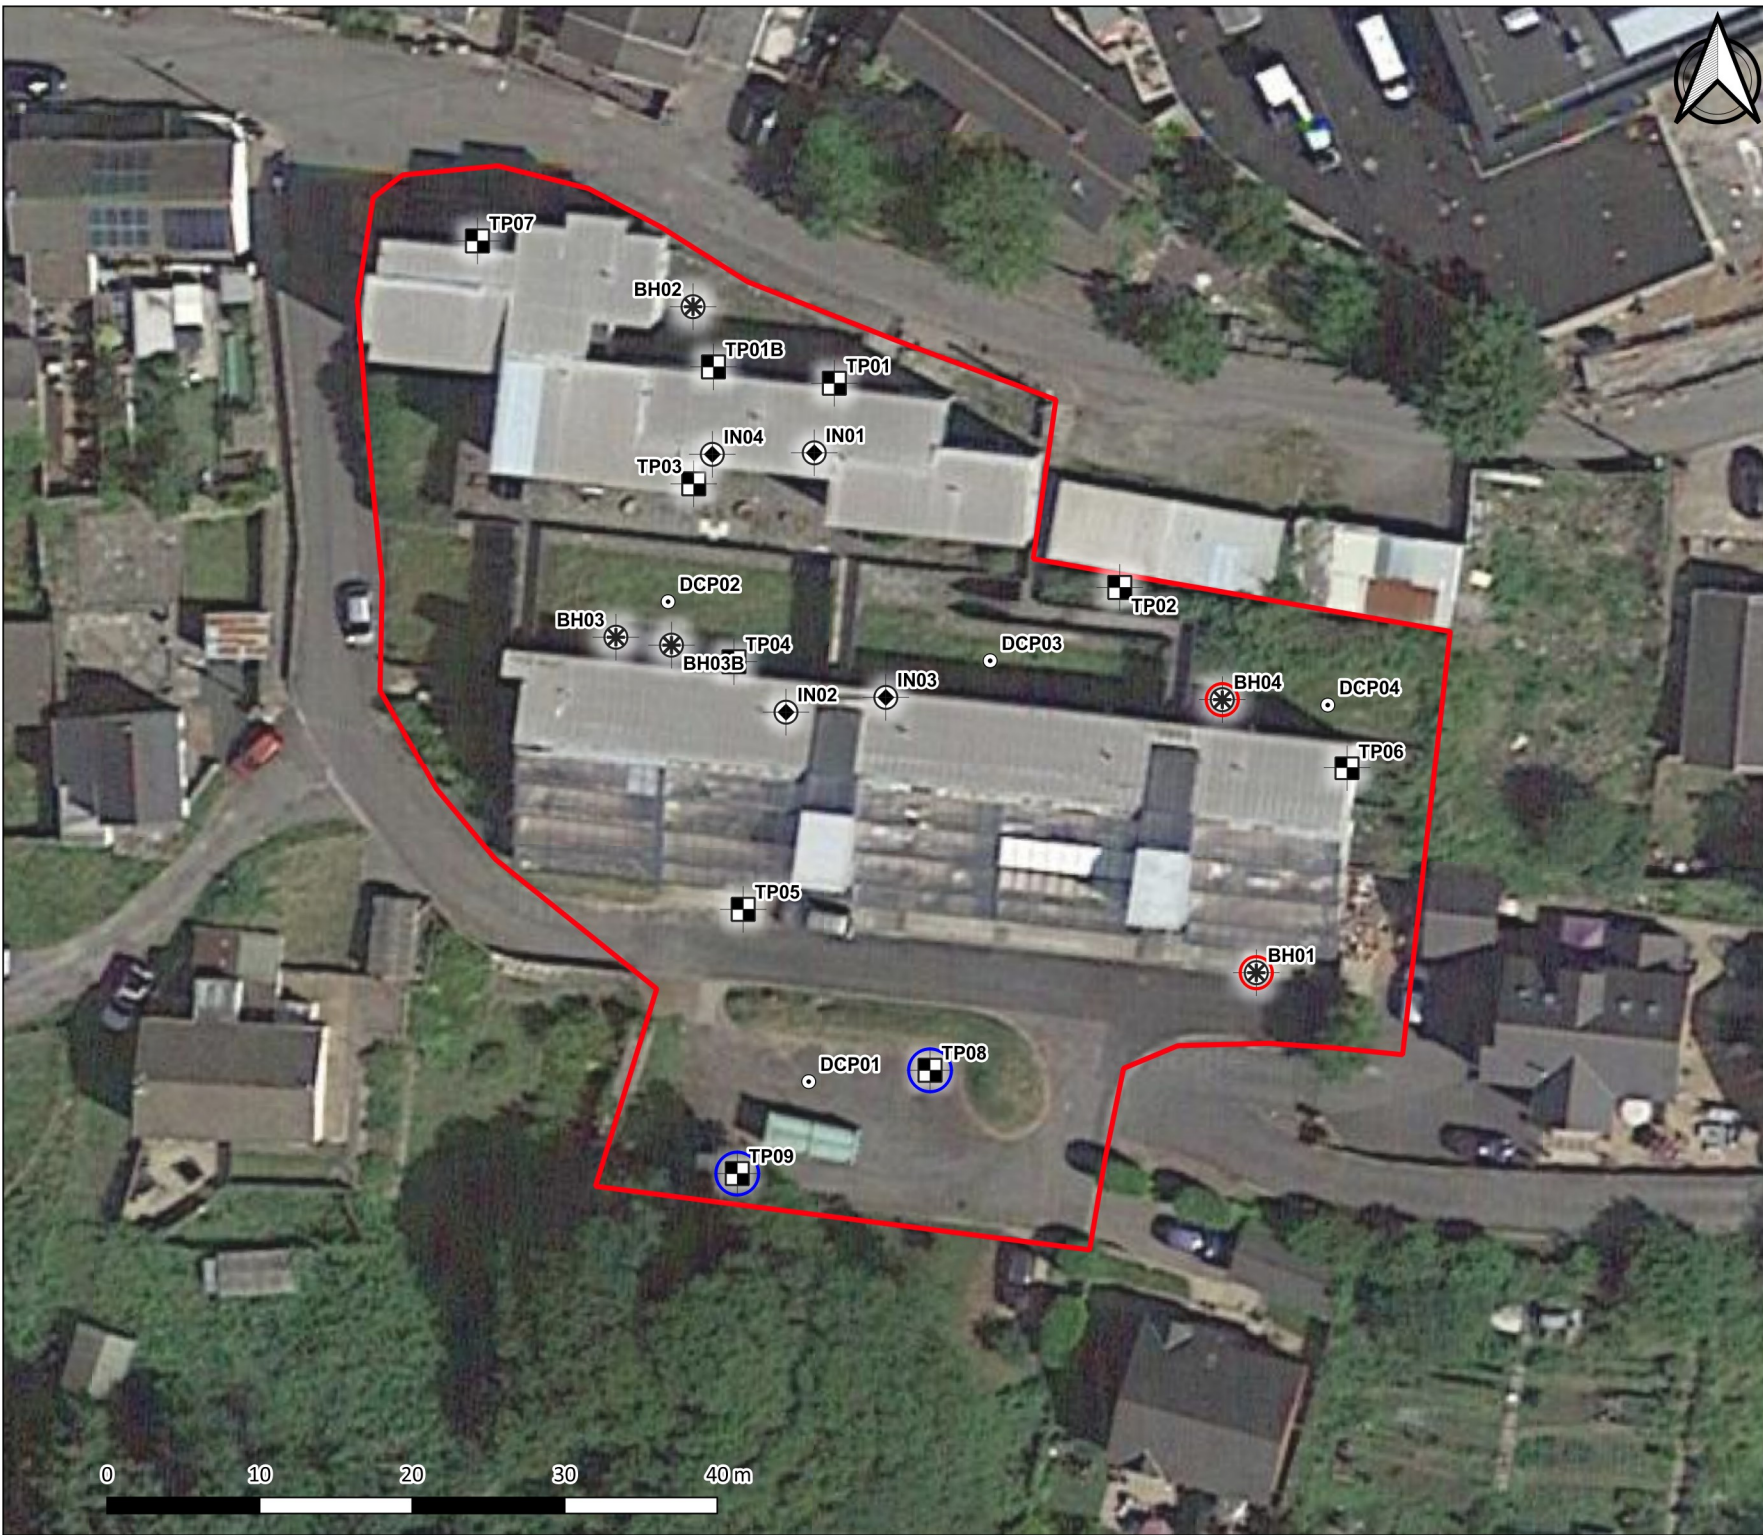
- Site Boundary
- Trial Pit
- Rotary Borehole
- DCPs
- Concrete Cores
- Infiltration Testing
- Water Monitoring Installation

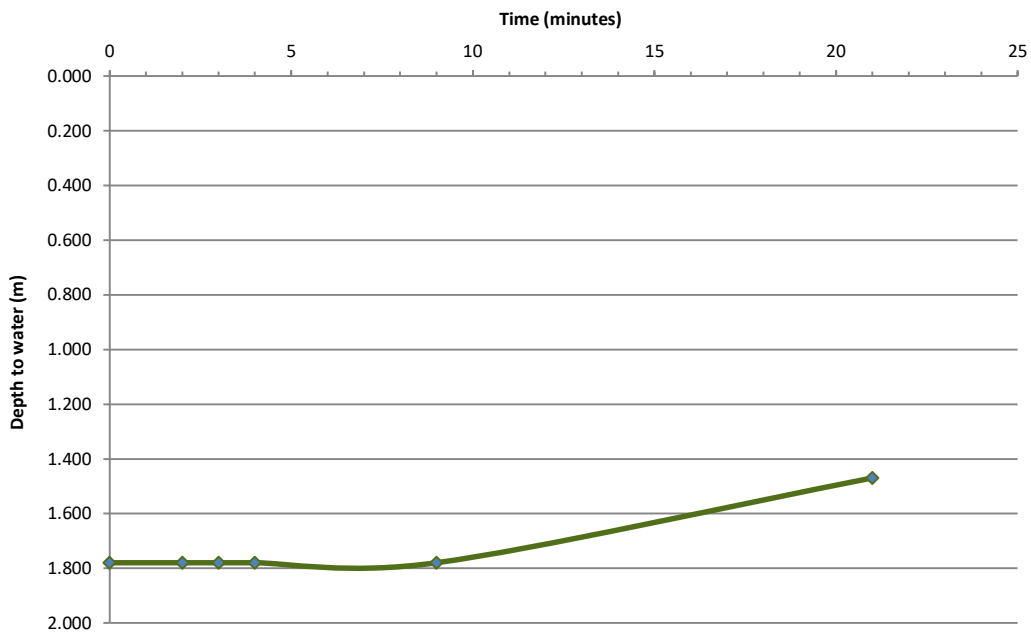
Test abandoned due to rising water level caused by collapse of trial pit sides.

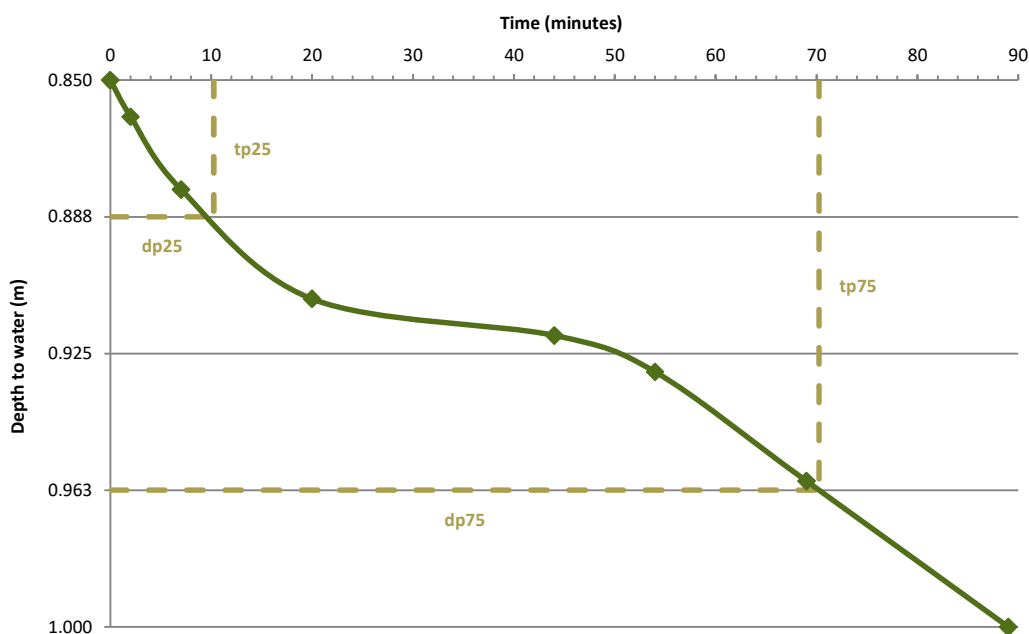
$$f = \frac{V_{p75-25}}{a_{p50} \times t_{p75-25}}$$

$V_{p75-25}$ Effective storage volume of water between 75% (dp75) and 25% (dp25) effective depth	0.07875	m <sup>3</sup>
$a_{p50}$ Internal surface area up to 50% effective depth and including the base	1	m <sup>2</sup>
$t_{p75} - t_{p25}$ Time for the water level to fall from 75% to 25% effective depth	3600	s
<b>f</b> Soil infiltration rate	<b>1.59E-05</b>	<b>m/s</b>

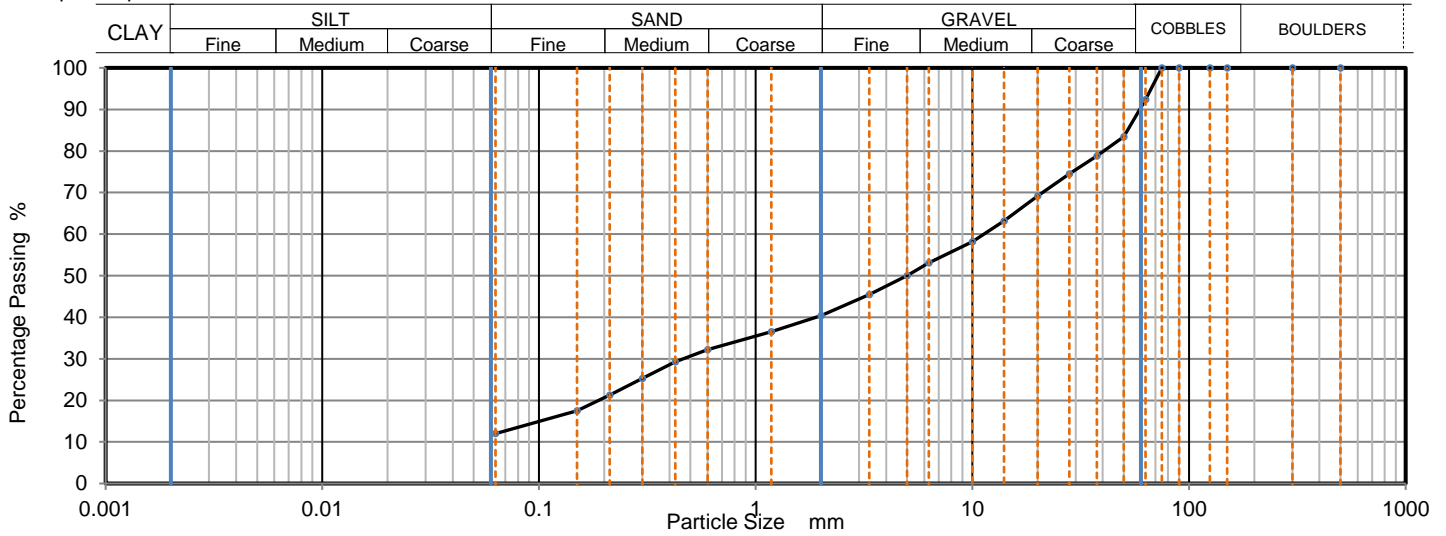
Depth Top [m]: 0.80  
Depth Base [m]: Not Given  
Sample Type: B

Sieving		Sedimentation	
Particle Size mm	% Passing	Particle Size mm	% Passing
500	100		
300	100		
150	100		
125	100		
90	100		
75	100		
63	92		
50	83		
37.5	79		
28	75		
20	69		
14	63		
10	58		
6.3	53		
5	50		
3.35	46		
2	40		
1.18	37		
0.6	32		
0.425	29		
0.3	25		
0.212	21		
0.15	18		
0.063	12

Sample Proportions	% dry mass
Very coarse	8
Gravel	52
Sand	28
Fines <0.063mm	12

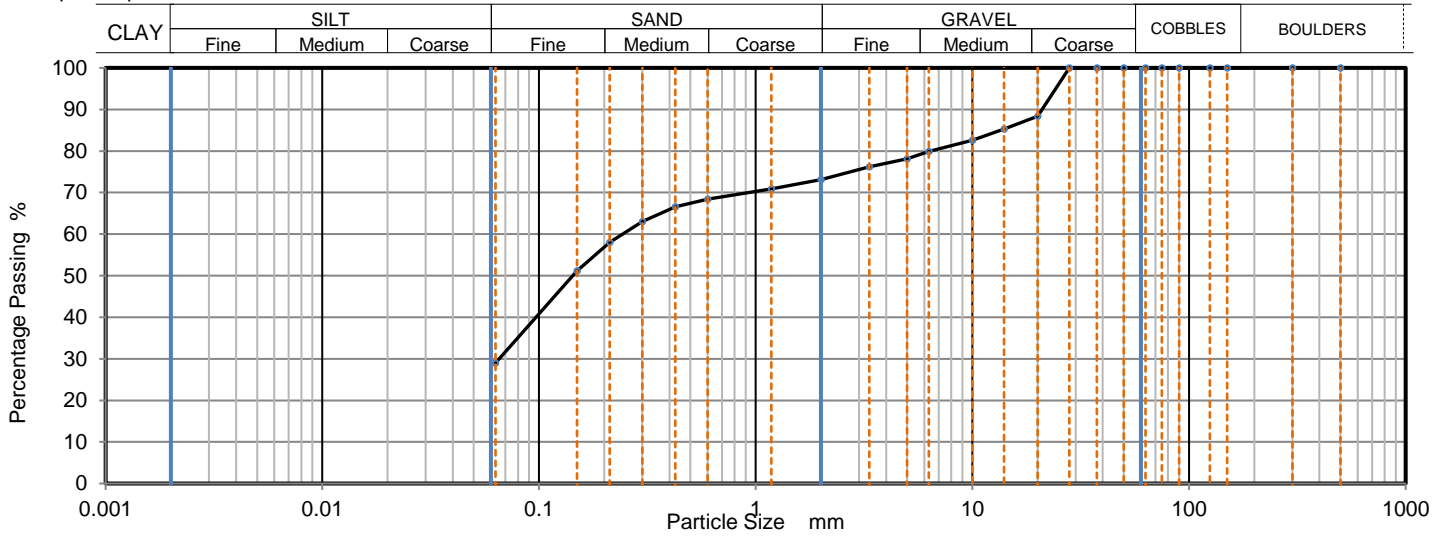
Depth Top [m]: 1.70  
Depth Base [m]: Not Given  
Sample Type: B

Sieving		Sedimentation	
Particle Size mm	% Passing	Particle Size mm	% Passing
500	100		
300	100		
150	100		
125	100		
90	100		
75	100		
63	100		
50	100		
37.5	100		
28	100		
20	88		
14	85		
10	83		
6.3	80		
5	78		
3.35	76		
2	73		
1.18	71		
0.6	68		
0.425	67		
0.3	63		
0.212	58		
0.15	51		
0.063	30

Sample Proportions	% dry mass
Very coarse	0
Gravel	27
Sand	43
Fines <0.063mm	30

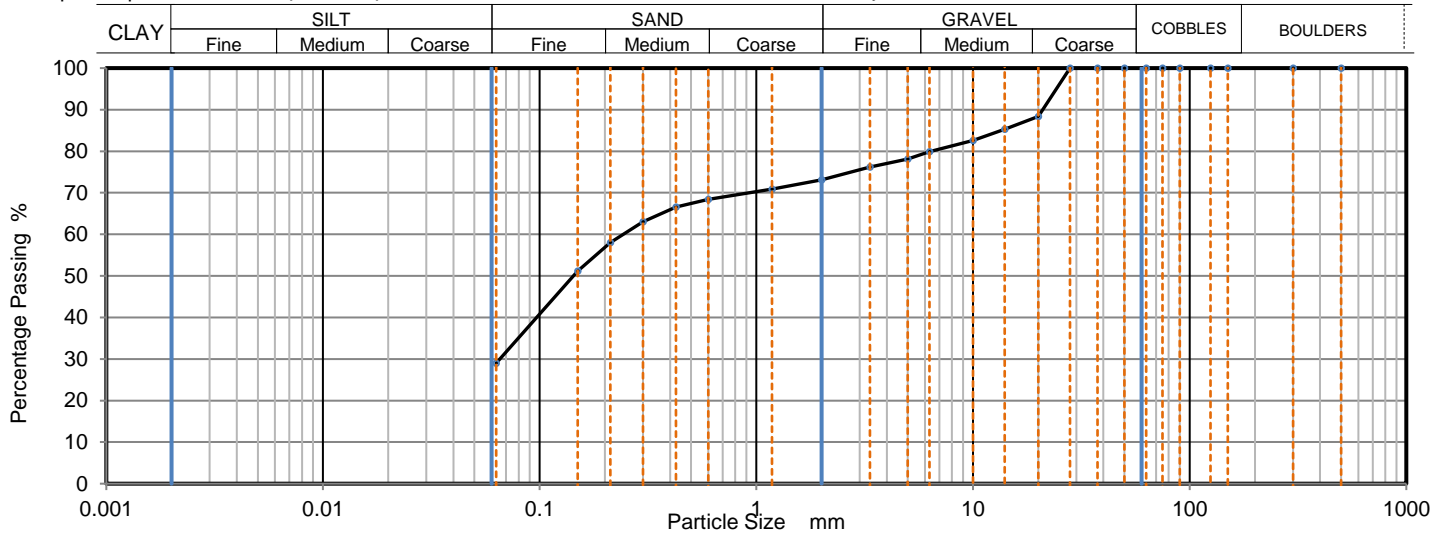
Depth Top [m]: 1.70  
Depth Base [m]: Not Given  
Sample Type: B

Sieving		Sedimentation	
Particle Size mm	% Passing	Particle Size mm	% Passing
500	100		
300	100		
150	100		
125	100		
90	100		
75	100		
63	100		
50	100		
37.5	100		
28	100		
20	88		
14	85		
10	83		
6.3	80		
5	78		
3.35	76		
2	73		
1.18	71		
0.6	68		
0.425	67		
0.3	63		
0.212	58		
0.15	51		
0.063	30

Sample Proportions	% dry mass
Very coarse	0
Gravel	27
Sand	43
Fines <0.063mm	30

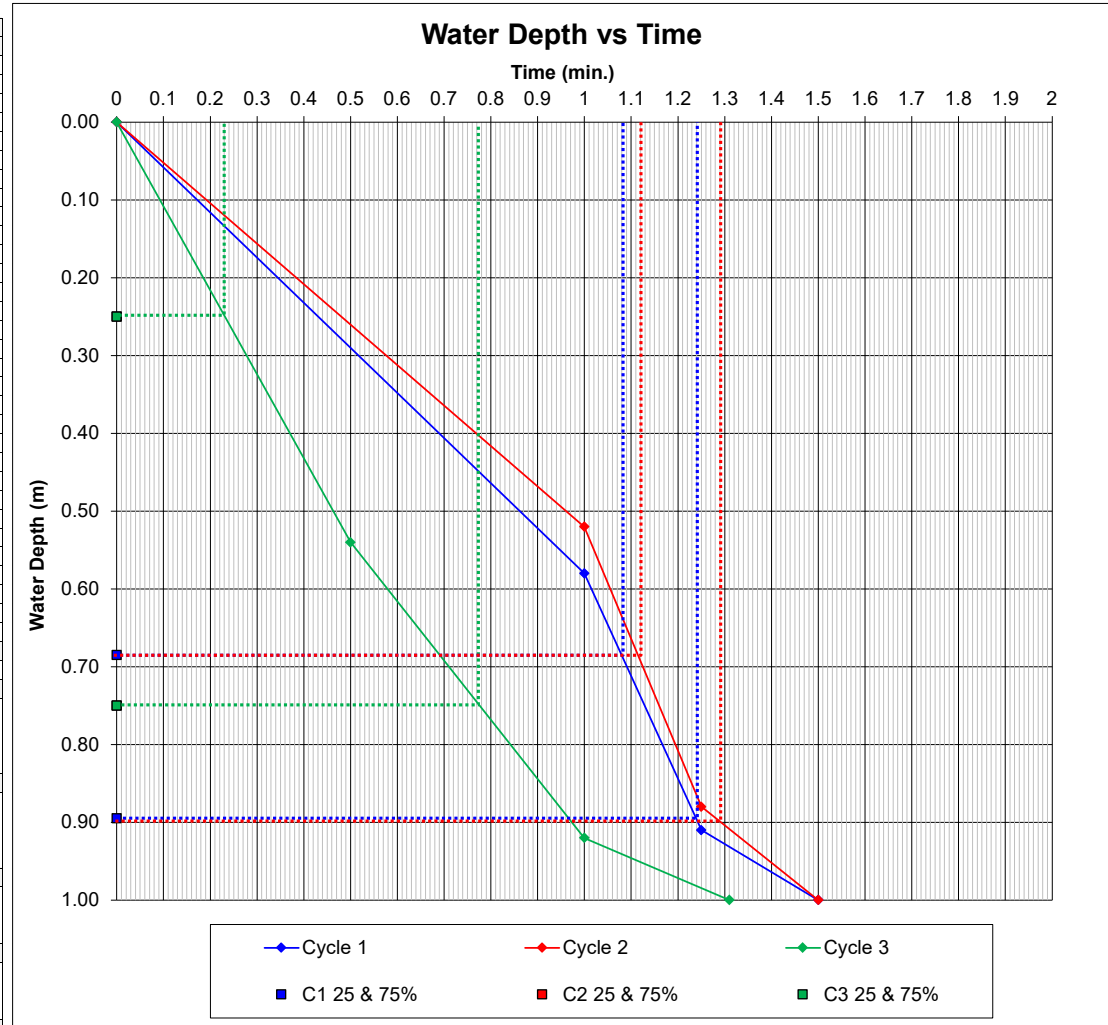
Over measured depth	0.59	1.29	1.29
<b>Soil Infiltration Rate (m/s)</b>			
Over 100% effective depth	7.1E-04	7.8E-04	8.9E-04
Over measured depth	7.1E-04	7.8E-04	8.9E-04
Over 75% - 25% effective depth	1.8E-02	6.8E-03	2.0E-03

Design Soil Infiltration Rate: 2.0E-03 m/s
